Map 3. GREAT BROOK TRAIL INVENTORY AND MAINTENANCE NEEDS

Deerfield, NH Trail Inventory  
August 2011

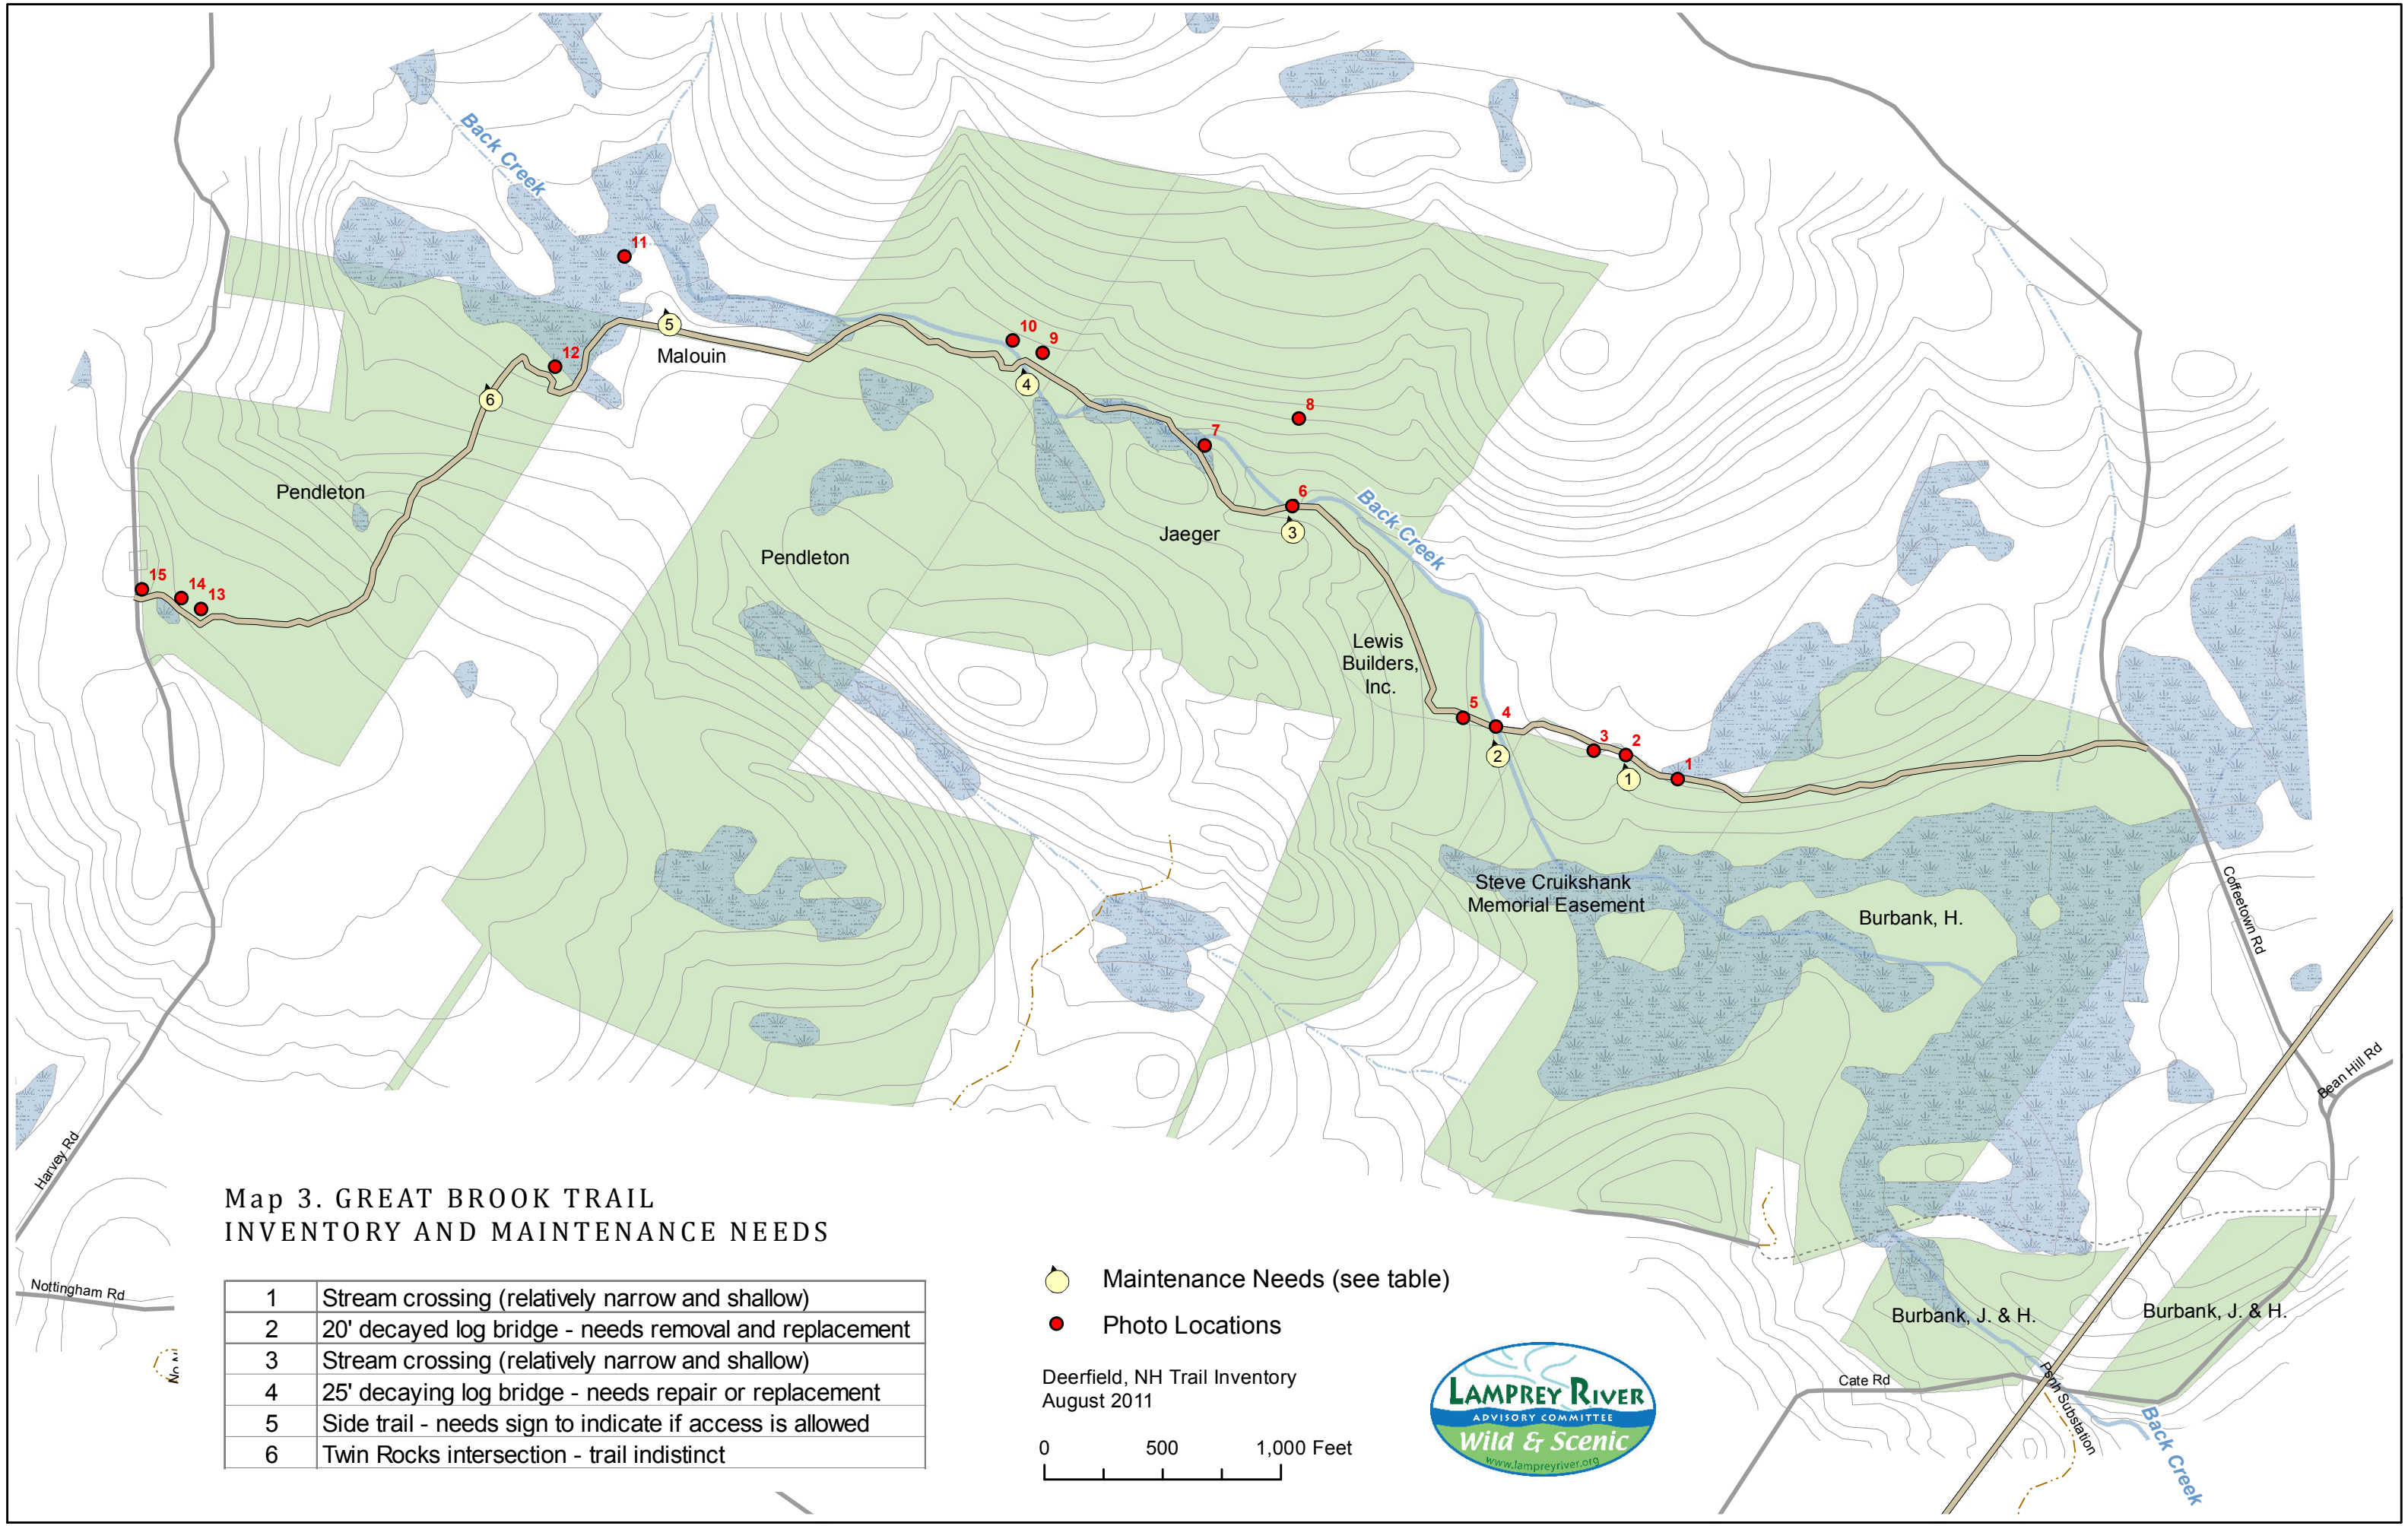
1	Stream crossing (relatively narrow and shallow)
2	20' decayed log bridge - needs removal and replacement
3	Stream crossing (relatively narrow and shallow)
4	25' decaying log bridge - needs repair or replacement
5	Side trail - needs sign to indicate if access is allowed
6	Twin Rocks intersection - trail indistinct
